Ponderosa Pool #2:  
Before preparation and application  
March 2003

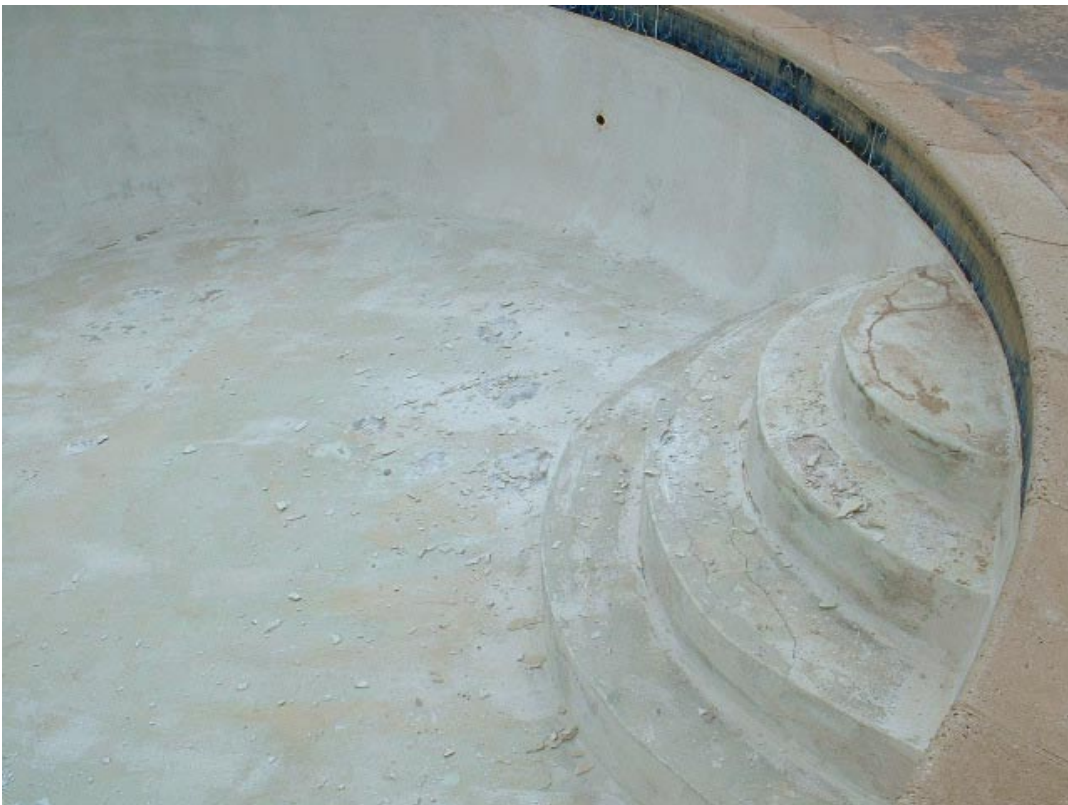
Ponderosa Apartments Pool #2:  
Steps in very bad condition. Cracking, spalling, etc.
