Residential Pool – Midland, Texas  
May 2005

**Project:** Residential swimming pool had 2-feet of concrete poured into deep end several years ago in the attempt to make the deep end more shallow. The added concrete had severely separated from original pool bottom. Original pool paint was starting to delaminate from plaster.

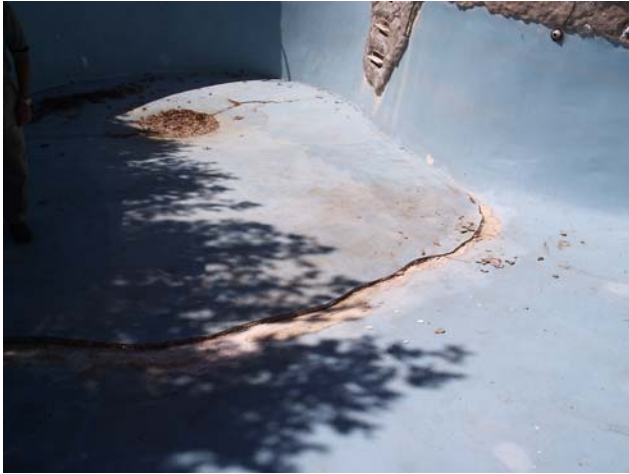
Large separation from poured concrete shown

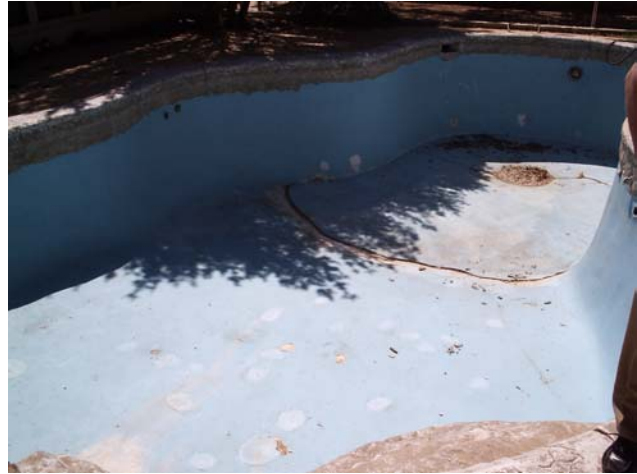
Several hollow spots are needed to be repaired

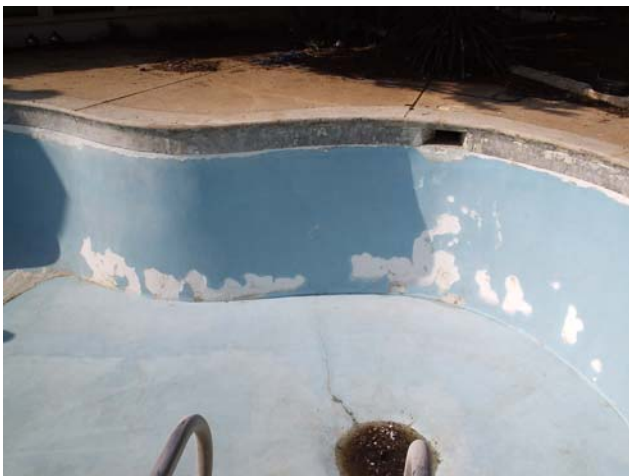
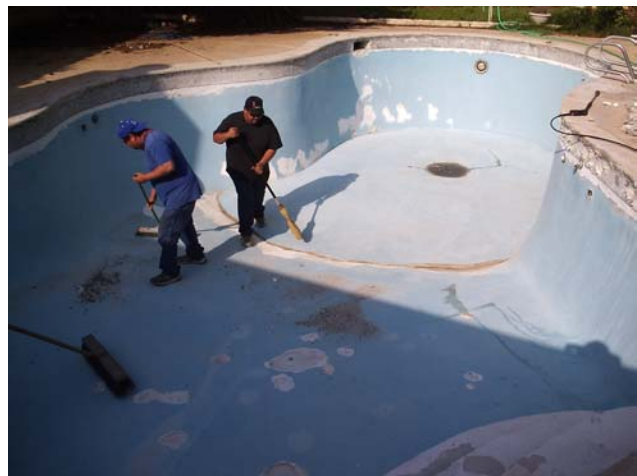
Preparation included vacuum, high-pressure water blast, and degreasing several times

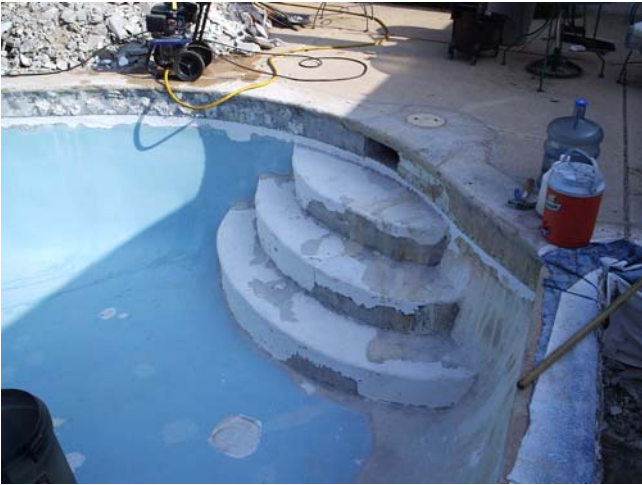
Steps were in need of repair, refurbishing

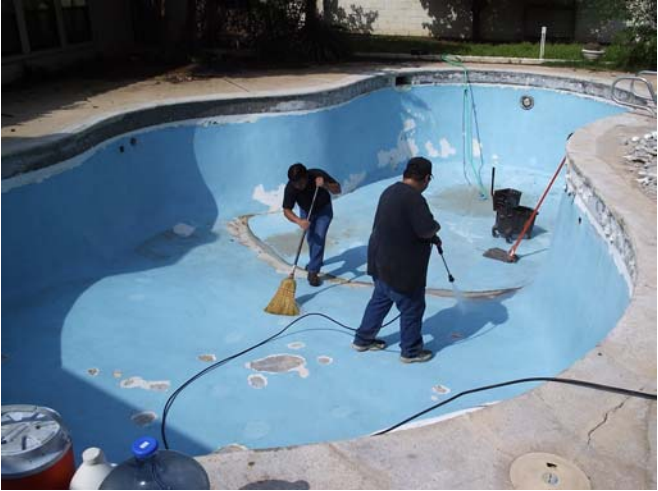
High-pressure water cleaning with tri-sodium phosphate detergent.

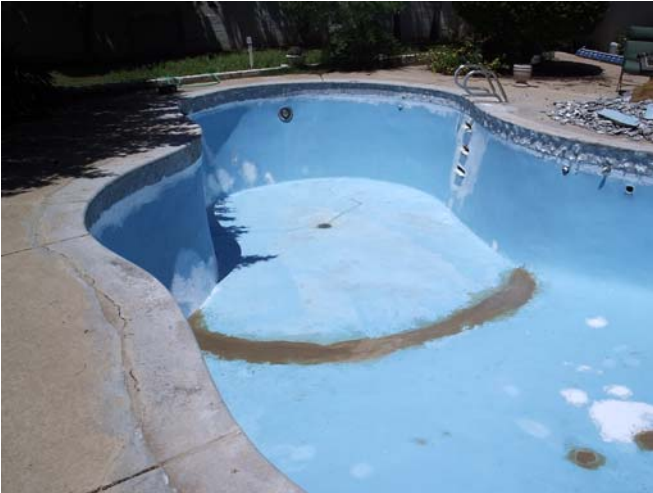
Refurbishing grout material to repair large crack and holes

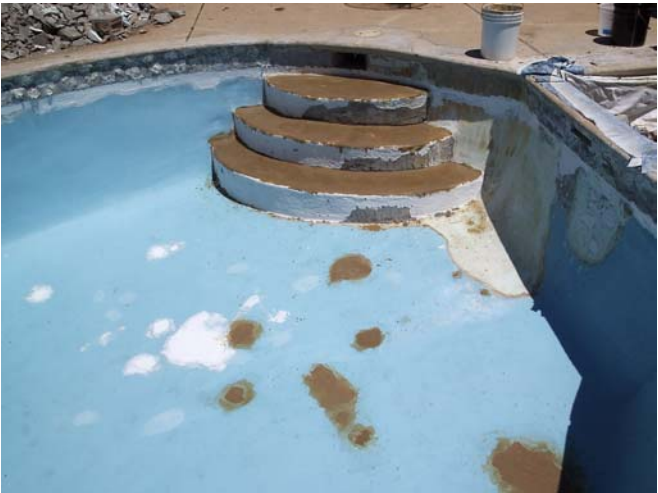
Steps refurbished

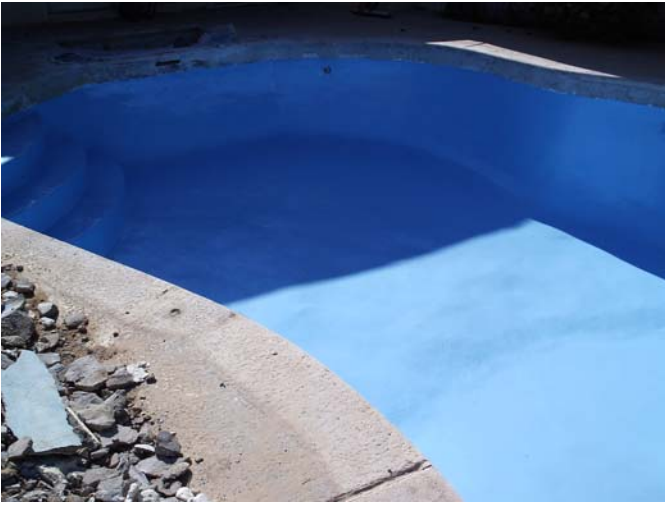
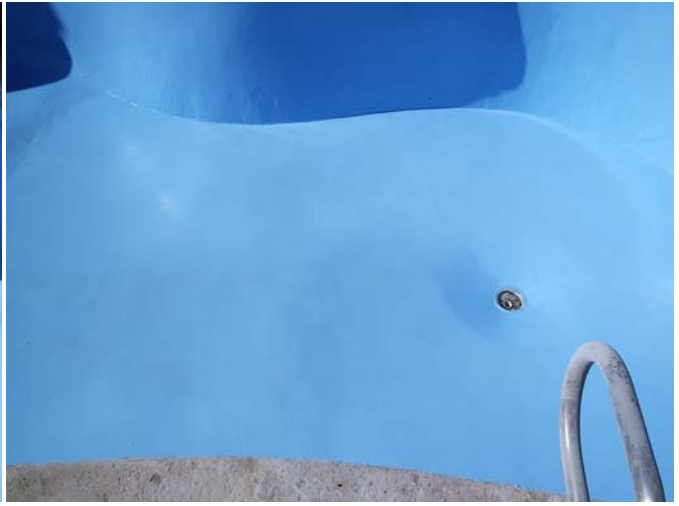
CeRam-Kote 99P Blue applied in three passes
